## Objectives

- Technology demonstration of InspecTerra's proprietary iCamm scanning tool for evaluating and mapping corrosion under insulation (CUI)
- Scanned the bottom section of a large insulated separator vessel

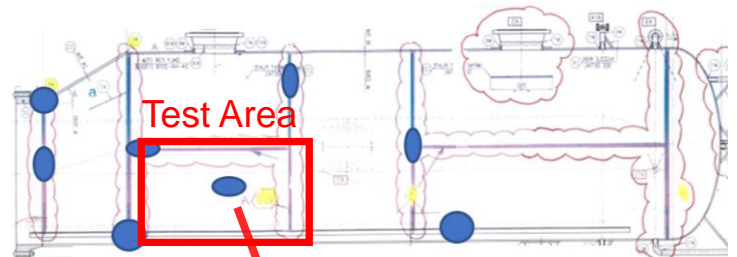
- Inspected the 1.4 x 1 m test section in less than 1 hour
- Scanned directly through the insulation and cladding
- No surface preparation or insulation removal required
- The defected area was accurately detected
- The impact of welding is obvious in the inspection results
