## Objectives

- Demonstration of InspecTerra's passive magnetic iCamm inspection technology as part of DnD's IDEaS Corrosion Detection in Ships (CDIS) Sandbox in Halifax, Nova Scotia
- Scanned for corrosion on ship deck panels under a layer of non-skid coating
- Deck panels were 7 - 9 mm thick steel plates

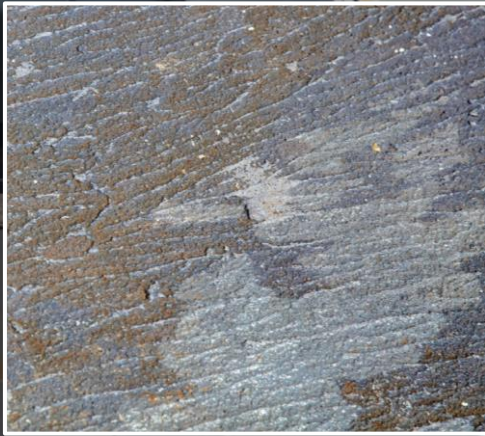
Rough non-skid coating layer

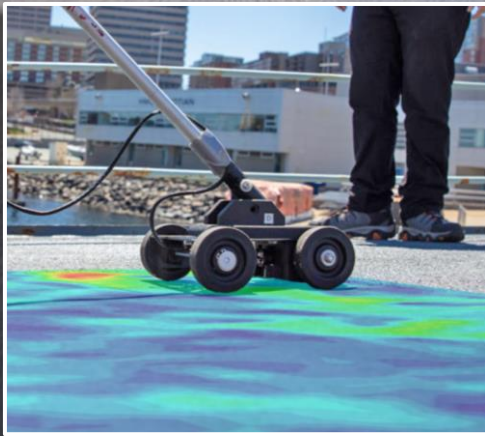
iCamm Scanner
